New perspectives on the structure of the Antonine Wall

10. New perspectives on the structure of the Antonine Wall

Tanja Romankiewicz, Karen Milek, Chris Beckett,
Ben Russell and J. Riley Snyder

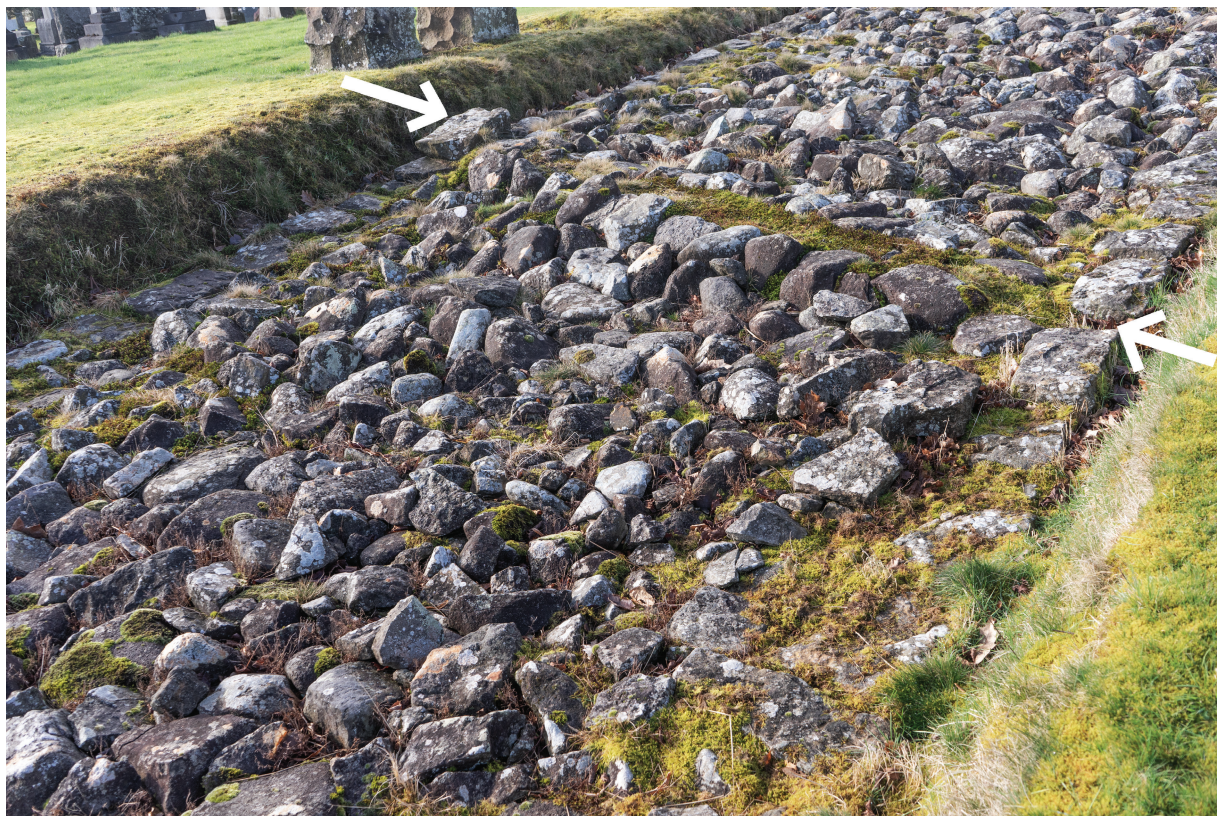
Figure 10.4. Hillfoot cemetery, New Kilpatrick, western part, sector 9. Stone base of Antonine Wall with angular, dressed kerbstones and rubble core. Arrows mark position of stone drain, i.e. the culverts recorded at intervals (© T. Romankiewicz).

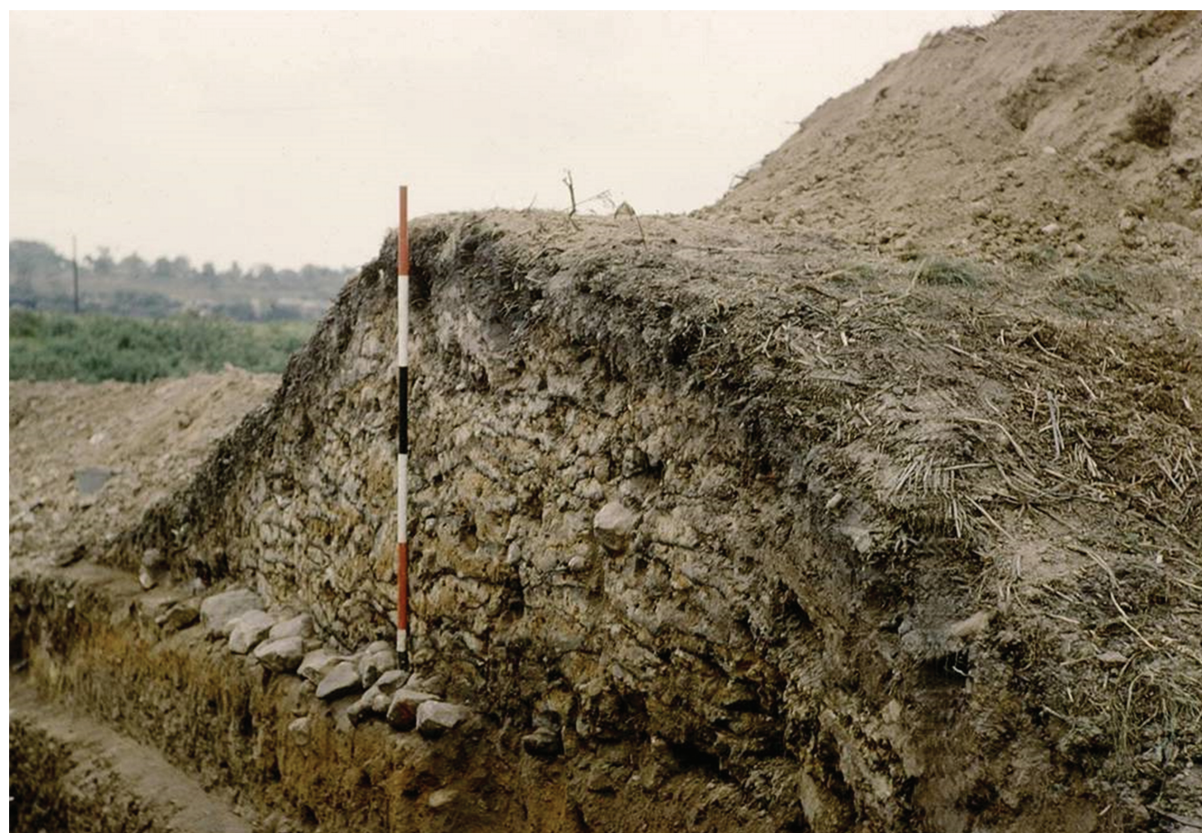
Figure 10.7. Section through Antonine Wall at Tentfield, central part, sector 3 (photograph and drawing). Turf core (grey-green) flanked by original turf faces to north and south (mid-green), these were contained by kerbstones (yellow). An additional turf face was added to north and south, on top of kerbstones, with potentially some later slumping to south (Photograph by A. Robertson, ©Crown copyright Historic Environment Scotland; drawn by T. Romankiewicz after Robertson 1964: Fig 5).

In the turf sections of the Wall, individual turves bulging beyond the line of the kerb of the stone base were noted already by the Glasgow Archaeology Society and attributed to distortion caused by the pressure of earth above and military movements (GAS 1899: 127). A re-assessment of section No. 11 at Croy corroborates this observation, linking the protruding turves to accidental slippage rather than to a deliberately built extension (see Figure 10.1). At St Flannan's Church, the material in front of the southern turf cheek (Figure 10.5, light green), seemingly much better layered than the turf cheek above the kerb, could well represent turf laid against a failing original face. At Tentfield, Robertson inferred repairs or slippage seen in the form of regular turfs stacks recorded in front of the original cheeks (Figure 10.7). She admitted that it was hard to discern whether these were deliberately layered and thus constructed as cheeks or simply slipped from the superstructure above. While the first cheeks had their footpoints bracketed by the kerb, i.e. the kerb would have protruded, Robertson's record drawings suggest that the second cheek was carefully built on top of the kerb stones and against those original turf cheeks, presumably to counteract their sagging outwards at the front and rear of the Wall (Figure 10.7) (see Robertson 1964: 193, Fig. 5).
